Manhole Inspection Summary

Manhole # S29SS1005MH

Insp Date: **6/19/07 1:59 PM**

Location Address: **4802 WILMSLOW RD**

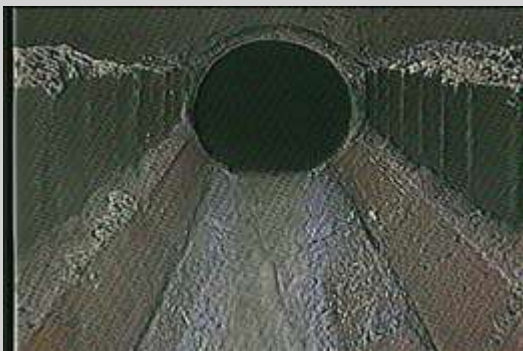
8 in. Circular Gravity Sewer Pipe In @ 6 O'Clock

Rod and Bar (Angled)

Pipe Material: **Clay** ☐ Pipe Lined

Infiltration: **None** Pipe Seal Cond: **Unknown**
